Wheel bearing kit including wheel bearing and axle nut

fits Audi A2, Seat Cordoba, Seat Ibiza IV, Škoda Fabia, VW Polo, VW Fox

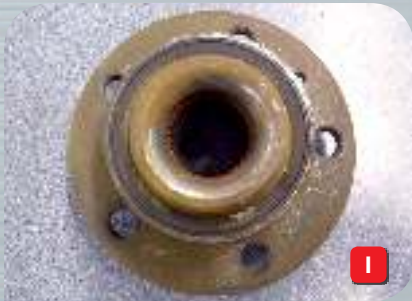
The wheel bearing makes a lot of noise when driving.

Water is getting into the wheel bearing due to a damaged sealing washer and rust is forming, see photos (1) and (2). The sealing washer (3) located between the CV joint and the wheel hub is made of plastic and is easily damaged during removal or due to external factors. When the sealing washer is damaged, it no longer makes proper contact. Water can get inside the wheel bearing more easily once the sealing washer is damaged or dirty. The consequences are premature failure of the bearing and a lot of noise.

Look out for damage to the sealing washer! As a general rule, SWAG recommends replacing the sealing washer when fitting a wheel bearing. Important: The sealing washer comes in two sizes (64 mm and 72 mm). Pay particular attention to the size (in inches) of the wheels!
