# SERVICE INFO

## Note on installing tensioning pulley 531 0317 10 with base plate fixing

**Part no.:** 531 0317 10

**INA 0076**

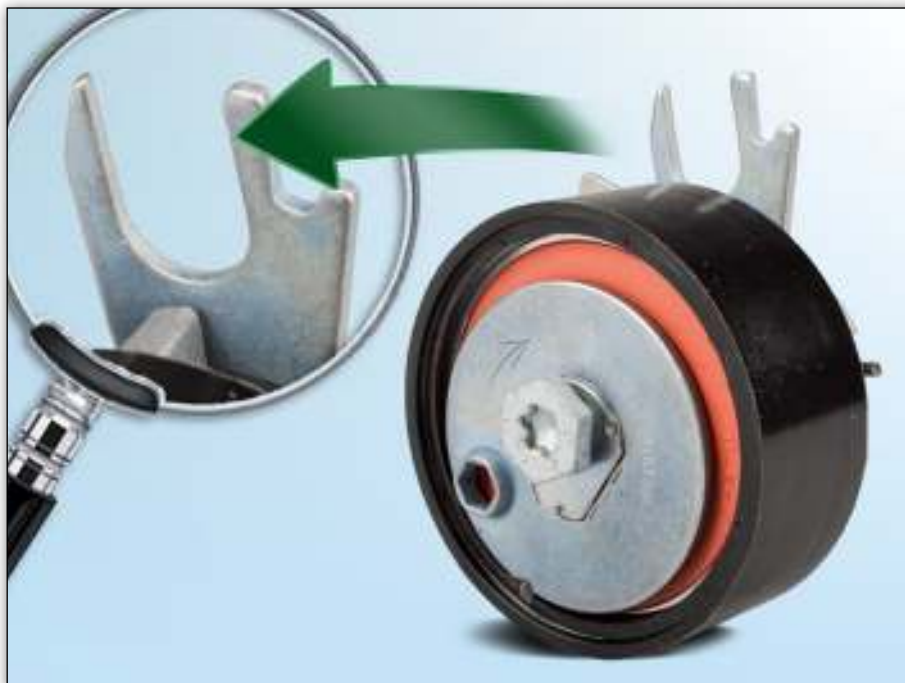
**Image 1:** 531 0317 10 — Tensioning pulley with base plate fixing

If the base plate is fitted incorrectly, this could cause the tensioning pulley to malfunction.

When installing tensioning pulley 531 0317 10, always ensure that the base plate is positioned correctly. The base plate must be correctly positioned in the designated retainer on the engine block.

It is important to ensure that the base plate is positioned correctly for all tensioning pulleys that feature a base plate fixing.
