Service Info

Tensioning arm 534 0325 10

Improved markings

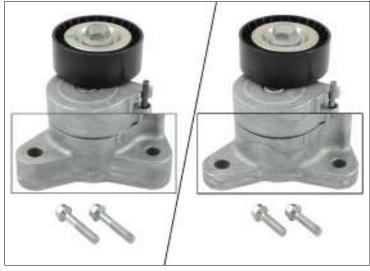
Image 1: Tensioning arm 534 0325 10 – Left, old version with fixing screws M8x40. Right, new version with fixing screws M8x30.

Please note that the fixing screws supplied are shorter to match the thinner mounting flange (image 1).
