Issue No.: 5/2012 – Filter inserts KX 178 D, KX 228 D, and KX 220 D (VW/Audi applications): risk of leaks due to assembly error

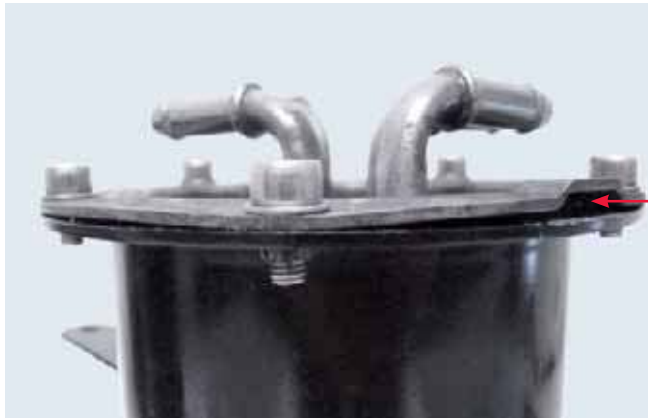
Point for correctly levering off the cover

However, the examination of the housing parts indicated a deformation of the housing cover, caused by incorrect opening and/or closing of the filter housing.

Figure 1: This housing cover (KX 178) was deformed by being opened and/or closed incorrectly.

Our advice: it is essential to ensure that no damage to the housing cover occurs when the filter element is professionally replaced.

- An unsuitable tool is used to remove the cover (VW recommends the use of the special tool VW number VAS6543).
- The cover is not levered off at the designated point (see photo); the same applies to the housing cover's gasket ring.
- The new gasket ring for the housing cover is not adequately wetted with fuel.
- The cover is only closed against the housing by tightening the bolts (the cover should be pushed on to the housing by hand and only then tightened with the bolts to create a perfect seal).
