### Issue No. 03/2012: Complaints after an oil change in VW 1.2 and 1.4 TSI engines

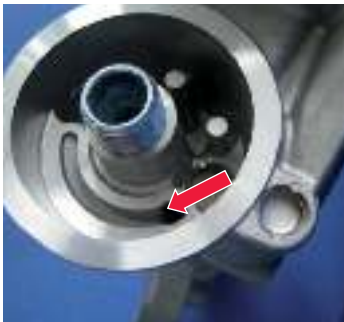
One of the gaskets on the filter is pushed onto the so-called anti-drain back plate (see Figure 1) in the flange by means of spring force in order to provide a seal when screwed on (see Figure 2). This mechanism only opens the drain when the filter is loosened during an oil change. The remaining engine oil drains completely into the oil sump and can be

Figure 1: View of the flange on the engine side with the anti-drain back plate

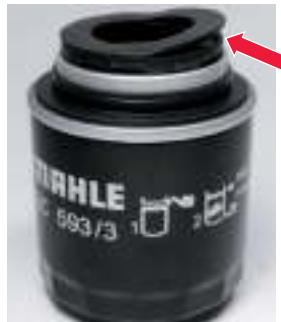
Figure 2: The upper gasket (raised for the sake of clarity) seals the drainage mechanism in the flange.

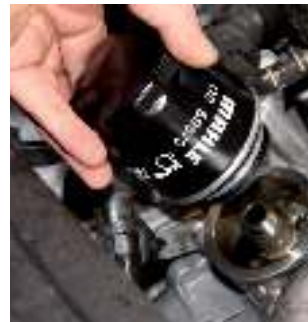
Figure 3: When loosening the old filter, make sure that no engine oil gets onto the belt drive or into the alternator.

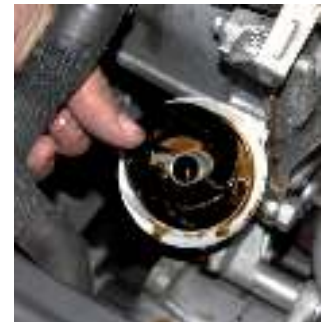
disposed of. It is possible that the old sealing ring sticks to the flange and is overlooked due to the used, black oil (see Figure 4). Nevertheless, the new filter can still be tightened without any noticeable problems.

Only once the engine is running will the oil pressure warning light up, for example, and flange or filter leakage occur. Under certain operating conditions, the oil pressure can drop so far that rattling noises from the timing chain tension adjuster and hydraulic lifters become clearly noticeable.

Figure 4: The old gasket can remain stuck in the flange and must always be removed.

**IMPORTANT!** Before installing the new filter, it is essential to locate the old gasket and remove it from the flange by hand, if necessary. It is also important to always coat the new sealing rings with clean engine oil prior to assembly.
