Issue no. 7/2016: Foreign object damage in the turbocharger

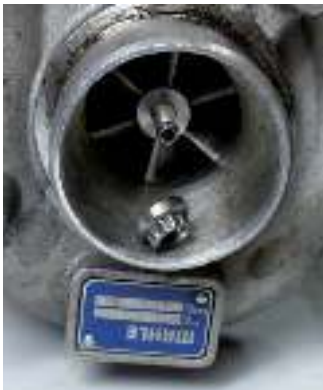
Figure 1

In the event of failure due to insufficient lubrication, the compressor nut may become loose (see Fig. 1) as a result of seizing of the radial bearing and immediate deceleration of the shaft. In some cases, the nut is flung into the air filter housing, where it remains and—in the worst-case scenario—is not discovered during the repair (see Fig. 2).

IMPORTANT! It is crucial that the loose impeller nut be found and removed. The entire intake section should be examined closely and the air filter element must always be replaced! It is also imperative that the complete charge air line be thoroughly cleaned and the intercooler replaced!

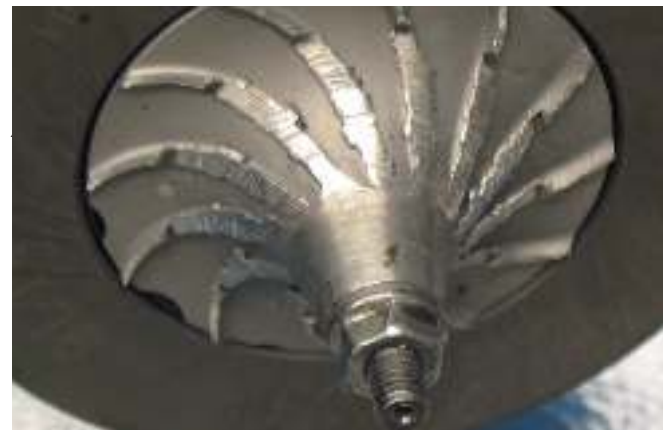
Figure 3

When the vehicle is running, the loose nut then ends up in the intake section of the new turbocharger, where it destroys the sensitive aluminium impeller (see Fig. 3). As a result, the new turbocharger can no longer compress the intake air, and the vehicle suffers a loss of performance.
