### Issue no. 04/2017: Leakage after fitting the oil filter insert OX 388D Eco in 1.6 and 2.0 TDI engines

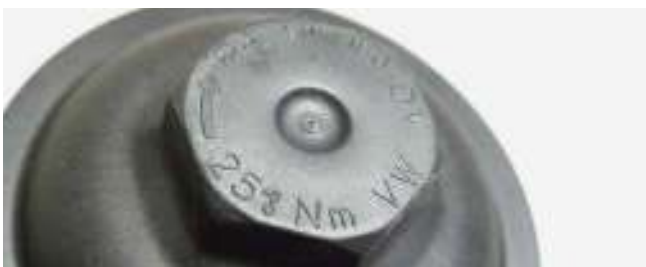
Figure 2: Torque specification on the housing cover

After the oil filter insert is changed, the cover is screwed back onto the housing; the permissible torque is **25 Nm** (+5 Nm).

**Important!** When changing the filter, always use a torque spanner to ensure compliance with the manufacturer's specifications. To prevent damage, coat the new gaskets with clean engine oil before fitting.

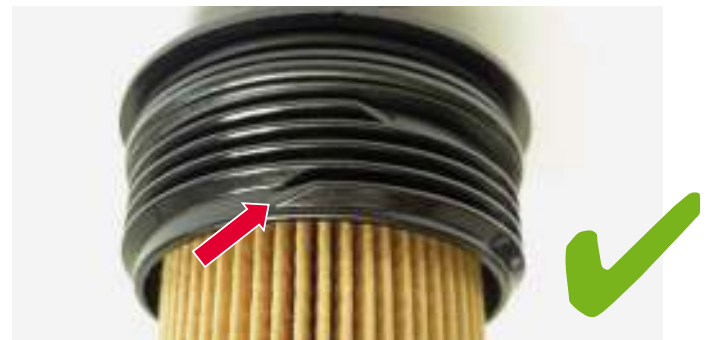
Figure 3: Undamaged thread

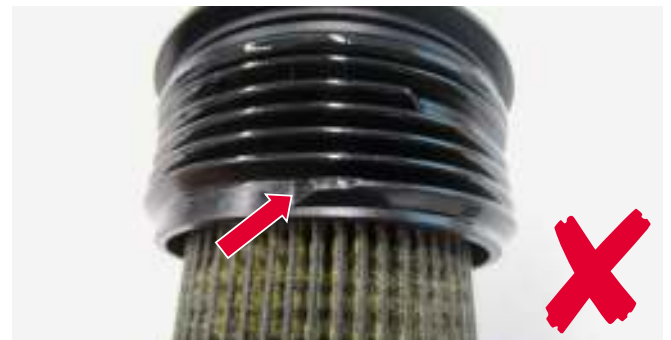
If too much force is applied, this can damage the thread and warp the cover, resulting in leakage from the housing cover and loss of engine oil.

Figure 4: Damaged thread
