Technical *Info*

Belt failure due to improper installation of the tension spring: CT 942 K1 (Hyundai 1.4-1.6-l/16 V, various models)

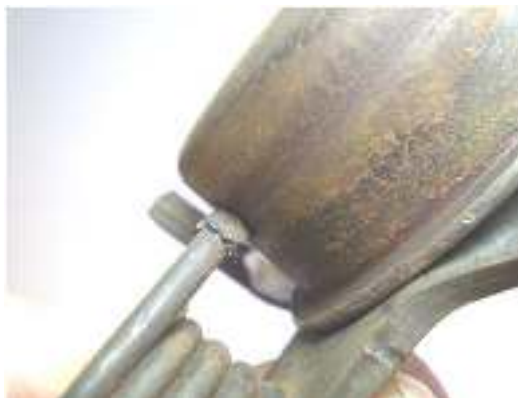
Otherwise it may come into contact with the surface of the bearing and cause the bearing to become blocked.

The correct installation position of the tension spring must always be checked.
