### Installation Tip for WPS3025 Coolant Pump for BMW 135i, 335i, 535i, 640, 740i from model year 2007

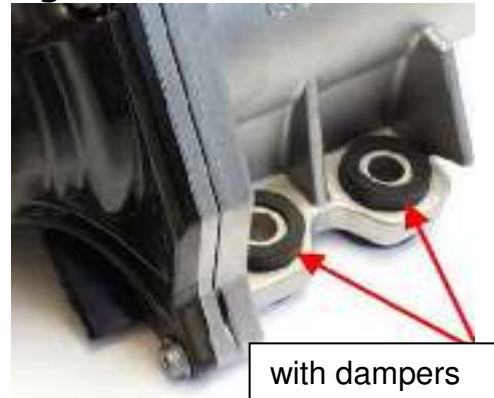
**Fig. 1**

The electric coolant pump which has been removed may have prefitted dampers at the three screw-fastening points (Fig. 1). The new WPS3025 coolant pump does not have these. The old fastening bolts are not suitable for reuse.

The aluminum bolts which have been removed (M8x36) must not be reused, but must be replaced with shorter steel bolts (M8x26).

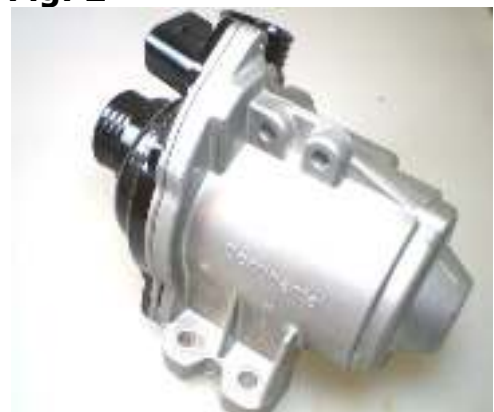
**Fig. 2**

The vehicle manufacturer has changed the coolant pump over to this new design without dampers (Fig. 2).
