# Technical *data*

## Tension pulley installation: CT 887 K1 for Daewoo and Chevrolet 1.4 16V, 1.5 16V, 1.6 16V

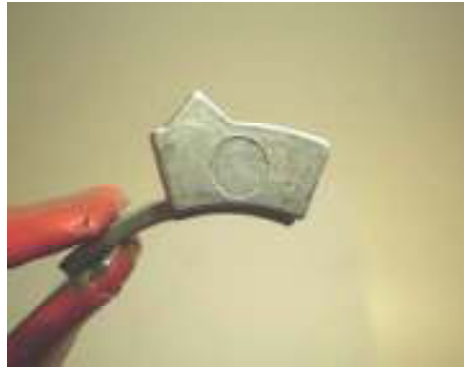
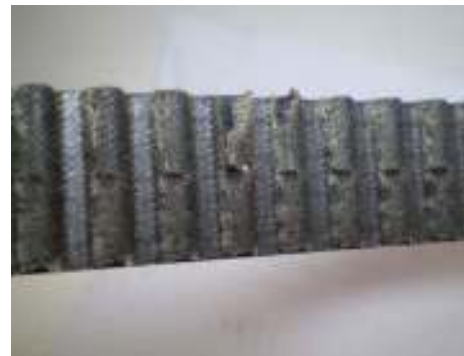
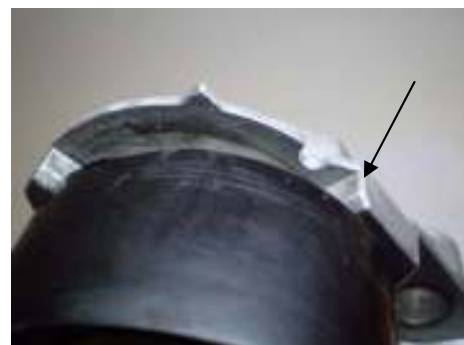
The pointer on the tension pulley breaks off during installation and could severely damage the belt.

There are two possible reasons for this:

1. Failure to loosen the water pump and to use it for adjusting the tension as described in the instructions.
2. During the specified two-fold rotation of the engine at increased tension (hole marking on the baseplate) the limit stop is subjected to excessive load and the movable pointer breaks off.

1. Make sure that the water pump is loosened, then turned using the corresponding tool OE (J-4249 2) and finally tightened again to 8 Nm.
2. The tongue of the pointer must be adjusted to ensure that it bears no load at any time. After turning the engine twice, both pointers must be perfectly aligned with one another.
