# Technical *Info*

## Belt failure due to improper installation of the tension spring: CT 942 K1 (Hyundai 1.4-1.6-l/16 V, various models)

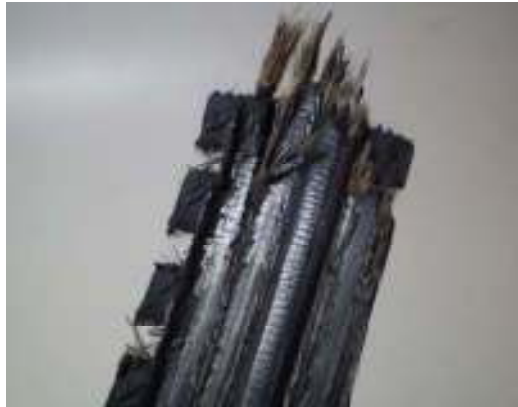
The belt drive fails due to a torn timing belt.

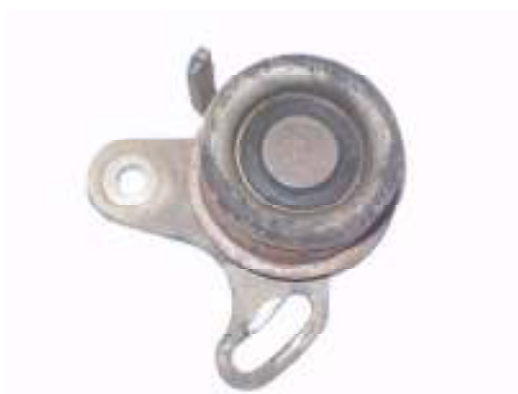
The back of the timing belt became overheated because the tension pulley was prevented from turning freely.

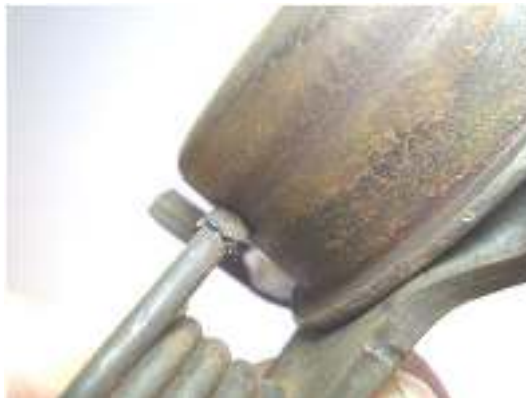
Otherwise it may come into contact with the surface of the bearing and cause the bearing to become blocked.

The correct installation position of the tension spring must always be checked.
