# SKF Technical Bulletin

## VKJA 3001- Importance of the correct boot tightening

AUDI A4, A6, SKODA Superb, VW Passat

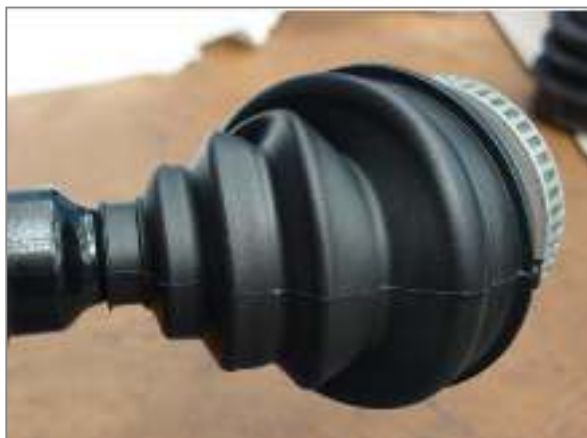
If the small diameter of the boot is tightened too close to the spline of the shaft, the boot coils may tear. If it's tightened too far (Picture 1), the boot will stretch excessively and will cause cracks (Picture 2).

Pic. 1 - Incorrect boot tightening

Before tightening the small boot clamps, ensure the boot is positioned correctly by moving the joint to its extreme angulation. The boot should not look too stretched on one side, and not too compressed on the other side.

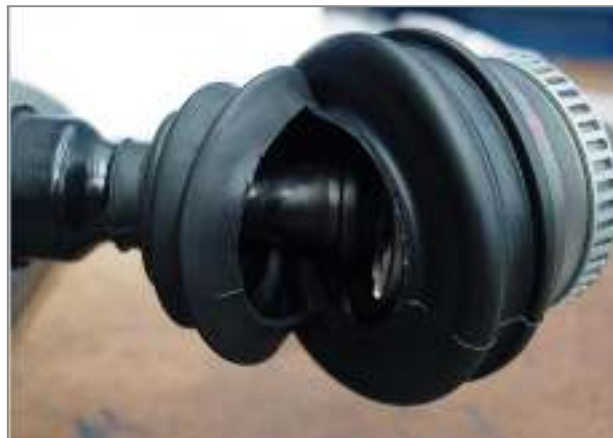
Pic. 2 - Boot cracks due to incorrect tightening

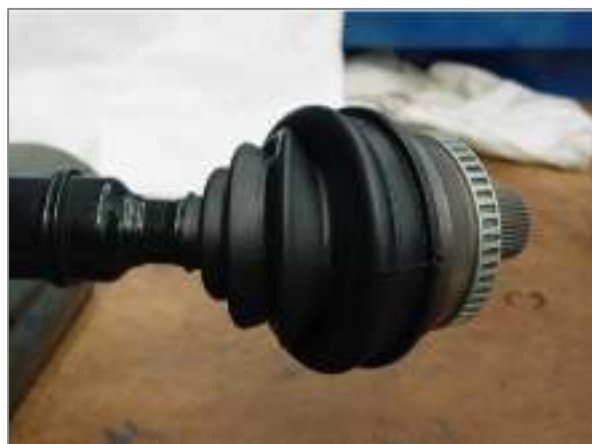
Pic. 3 - Correct position for boot tightening

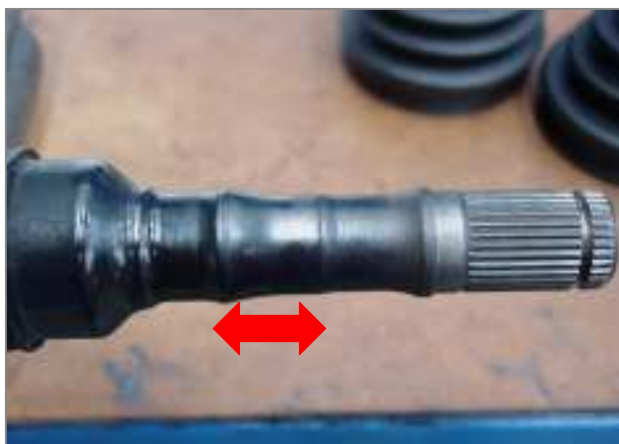
Pic. 4 - Slots for correct boot fitting
