SKF Technical Bulletin

VKJC 1045/1046/5205/5208 – Mandatory Stub-shaft kit replacement combined with driveshaft kit

VW Multivan V, Transporter V

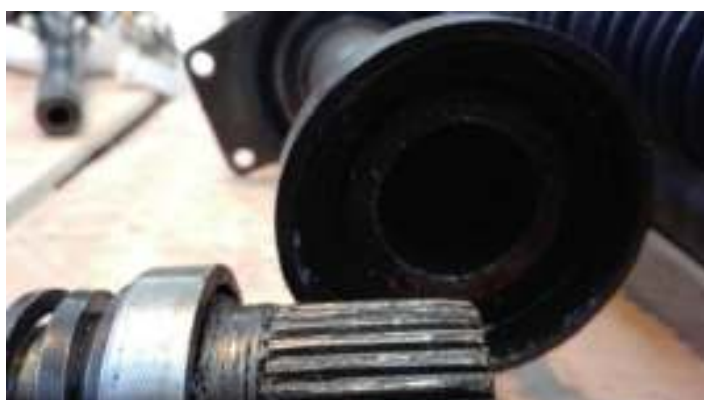
Pic. 1

Due to vehicle transmission dysfunctions on the above applications, there are issues with the original gearbox side tooting the driveshaft which leads to premature stub-shaft and driveshaft failure, as shown below on Pic 1 and Pic. 2.

The problem will persist if the driveshaft is replaced without a new stub shaft. Indeed, the tooting of the original stub shaft will present more tolerance than required, so it will prematurely damage the driveshaft tooting.

Therefore, for a complete and professional repair, SKF is offering both components as this is mandatory to replace the driveshaft and the stub-shaft at the same time.
