KF155.70U

Assembly/disassembly recommendations

NISSAN:	Primastar, Primastar FL,
OPEL:	Vivaro, Vivaro FL
RENAULT:	Trafic II, Trafic II FL
VAUXHALL:	Vivaro, Vivaro FL

IDENTIFICATION OF BRAKE DISC HUB KIT

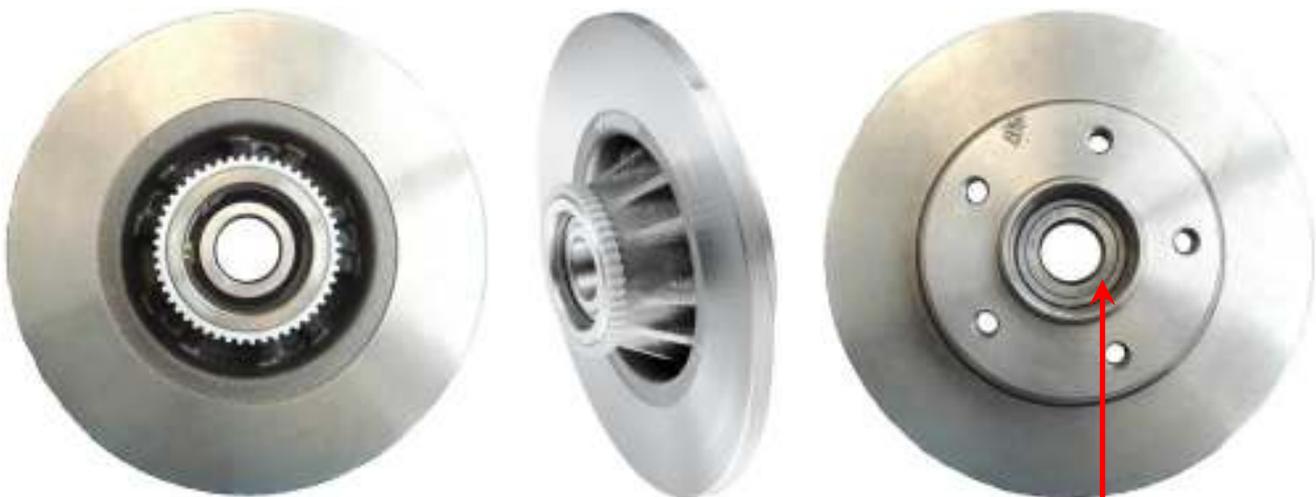
NTN-SNR KF155.70U

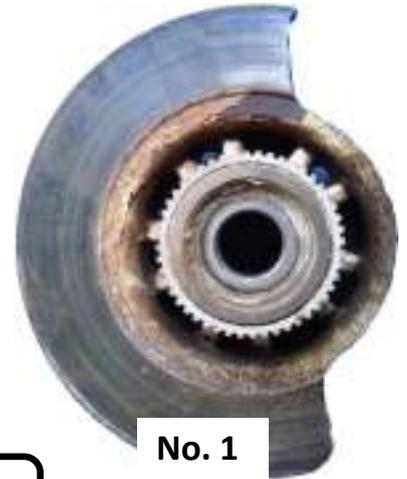
PROBLEMS WITH BROKEN BRAKE DISCS OR NOISE WHILST IN MOTION

Brake system malfunction.

This occurs when the calipers seize or the handbrake system locks up.

The disc remains locked and as a result the disc hub is subjected to a high increase in temperature. The brake disc inevitably fractures and breaks **(no. 1)**.

The vehicle should not be driven until repairs to the braking system have been made.

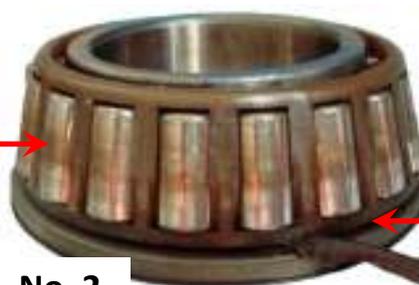
Incorrect installation of the disc hub on to the stub axle.

Incorrect fitment of the disc hub assembly when mounting it on to the stub axle can lead to the disc hub assembly being fitted askew, this damages the inner rings of the bearing and prevents correct adjustment, this results in a rapid failure of the disc hub. Incorrect installation of the inner ring, which detaches from its raceway groove, causes the bearing to open. The open bearing then causes serious damage to the seal, this then allows contaminants such a water to enter the bearing **(no. 2)**. This results in rust damage causing the bearing to become noisy and greatly shorten its service life **(no. 2)**.

Corrosion on the bearing

Damaged seal detached from its raceway groove

This failure is irreversible, the bearing and disc have to be replaced as a complete unit KF155.70U
