Technical Report #66

Failure reasons in rocker cover gasket

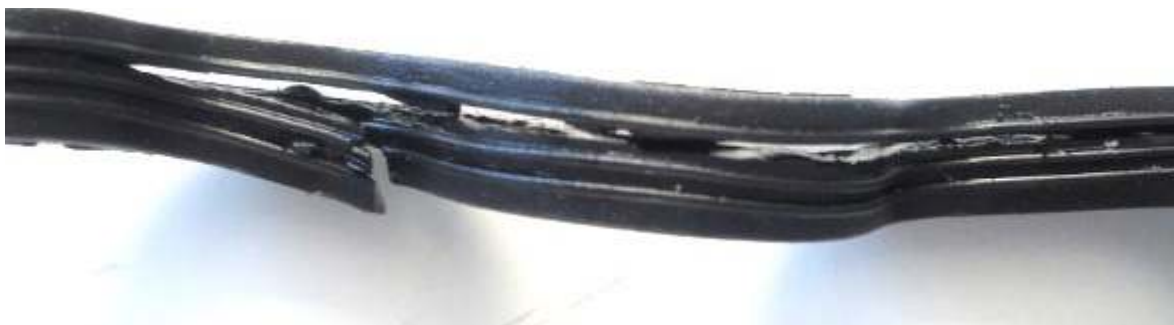
When an overpressure is applied, the material start begins to work in tensile forces and shear, for which it's not designed, ending up cracking.

In the following picture, we can see how the material has cracked due to the overpressure made by an excessive tightening:

It should be considered that the tightness of these type of gasket usually is between 8-12Nm, and if the screws are tightened without using a dynamometer, it's probable that its reaching the 25Nm easily without realizing it.

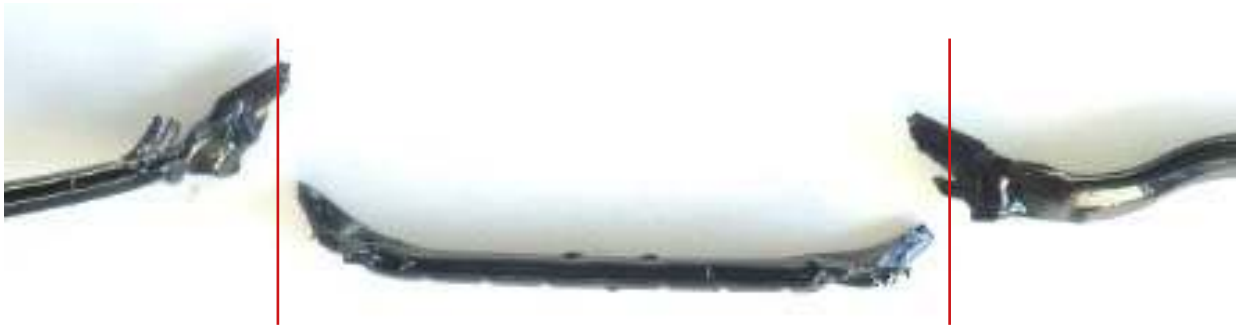
Other common fault, is to incorrectly place the gasket in its housing, so if we do the tightening processes with the gasket out of the socket, the cover would act as a shear cutting the gasket itself.

Gasket sectioned by the cover, due to improper positioning during assembly

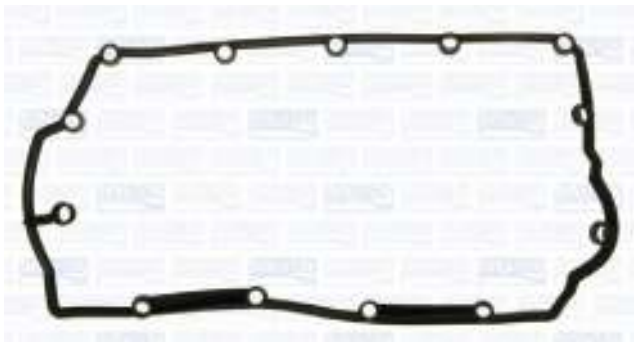
11095700

Here is an example of a very similar contour of gasket which mount a different rocker cover:
