## HD-Stabilizer links

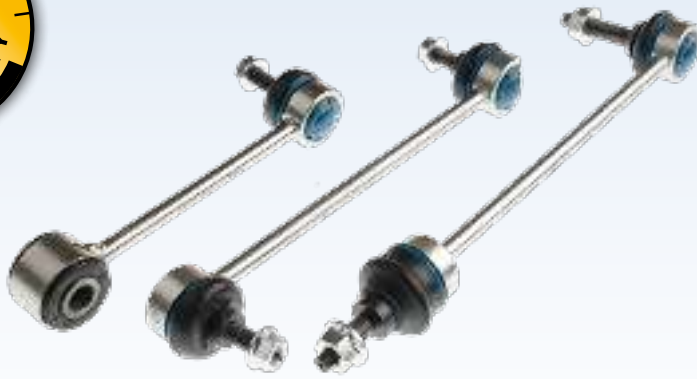
as OE

Intense strain causes wear and stress of the components

Premature failure of the ball joint  
Noise from the front axle

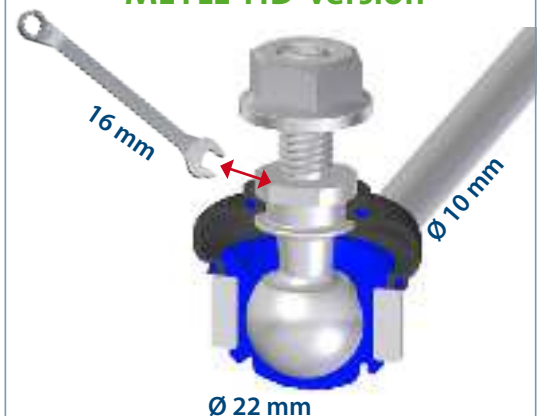
MEYLE-HD-version

- Enlarged ball diameter (22 mm)
- Reinforced link rod
- MEYLE high-tech grease
- Wear resistant blue plastic seat

Significantly longer service life thanks to reinforced design
