DPF Pressure Hose

Ford Mondeo 07 / S-Max 06 /
Galaxy 06 with 2.0 TDCi engine

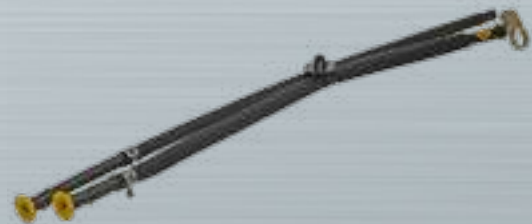
SWAG No. 50 94 5777

Repl. No. 1 440 559, 6G915H241AA

The problem is often remedied simply by replacing the pressure hose. This saves the vehicle owner an expensive repair.

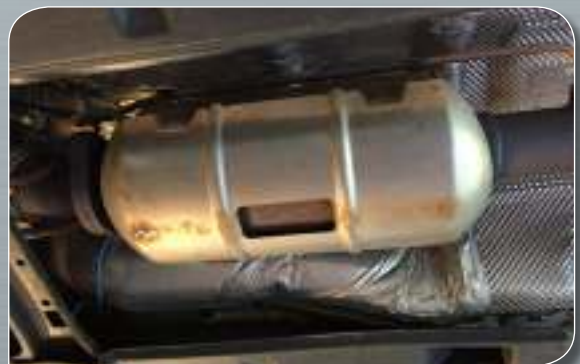
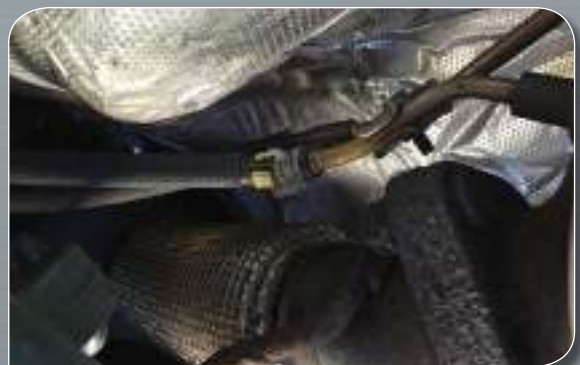
In the Ford models mentioned above, a pressure hose which routes the exhaust gas pressure to a differential pressure sensor is located on the DPF. If the differential pressure upstream and downstream of the filter is too high, this is a sign that the filter is saturated and needs replacing.

It may be that the pressure hose is blocked or has been scorched by the high temperatures, causing it to leak. As a result, the pressure actually prevailing at the differential pressure sensor is transmitted incorrectly or not at all. In this case, the engine control unit receives incorrect information and passes it on to the driver via the warning light.

Check the lines and hoses of the diesel particulate filter or sensor before carrying out a costly replacement.
