## Disk / Hub corrosion

### Loose wheel retaining bolts

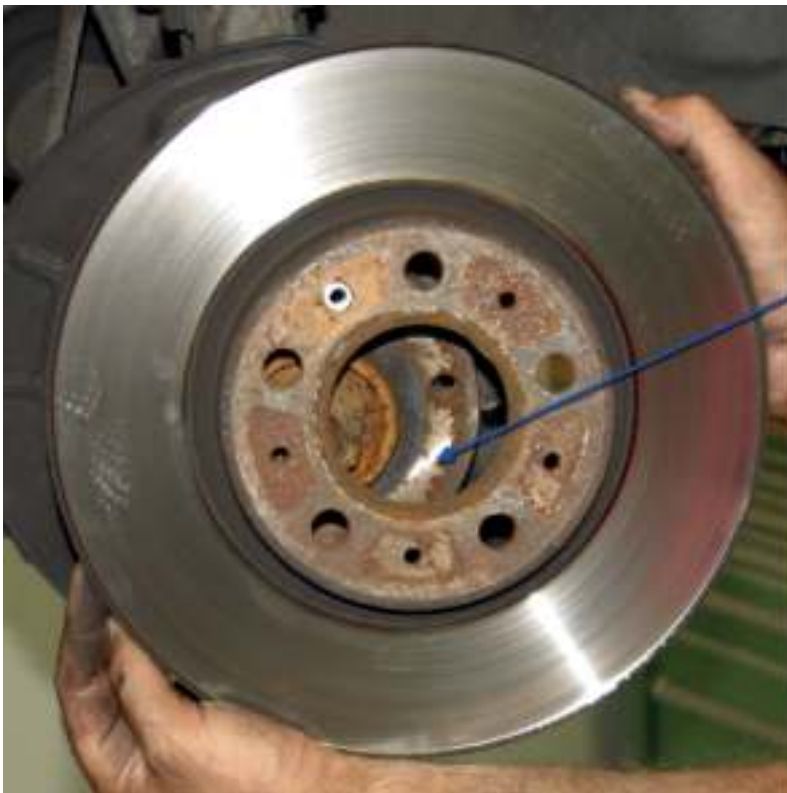
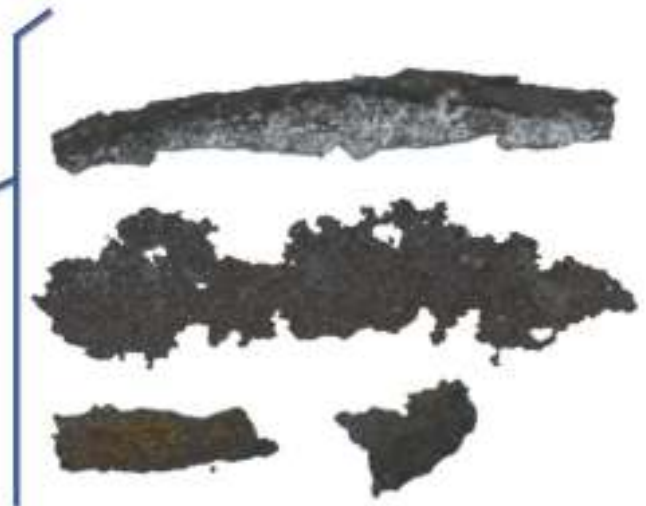
The reason identified for this problem is corrosion between the disc and hub mounting faces.

This is because corrosion present between the hub/disc mounting faces will gradually be converted to dust, thus resulting in a clearance, reducing the initial wheel bolt torque applied and allowing the bolt to loosen.

*Magnified rust pieces*

To prevent this always ensure the mounting faces of both disc and hub are clean and free from corrosion. If there is any doubt in the suitability for continued service of any component always replace with new guaranteed parts, where necessary in axle sets.
