Visual differences of the tensioning pulley 531 0565 30

Engine: 1.4 TDI, 1.9 TDI, 2.0 TDI

LuK AS Part No.: 531 0565 30

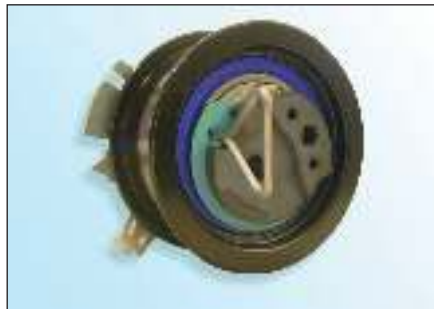
Fig. 1: 531 0565 30 (old version)

- Cam made from sinter metal
- Surface coat E-Coat (black)
- Blue bearing seal

The „old version“ of the tensioning pulley is **not** made completely redundant and can still be used and assembled in accordance with the instructions provided by the manufacturer!

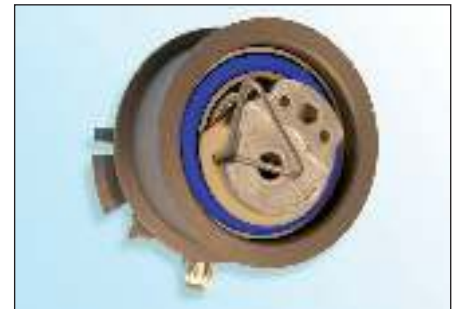
Fig. 2: 531 0565 30 (new version)

- Cam made from cast aluminium
- Surface coat Zinc phosphorous (light brown)
- Brown or blue bearing seal

When assembling the „new version“, ensure that the surface coat of the tensioning pulley is **not** damaged!
