Service Info

Bleeding process of CSC 510 0097 10

Modified hydraulic connection

Manufacturer: Dacia
Nissan
Renault

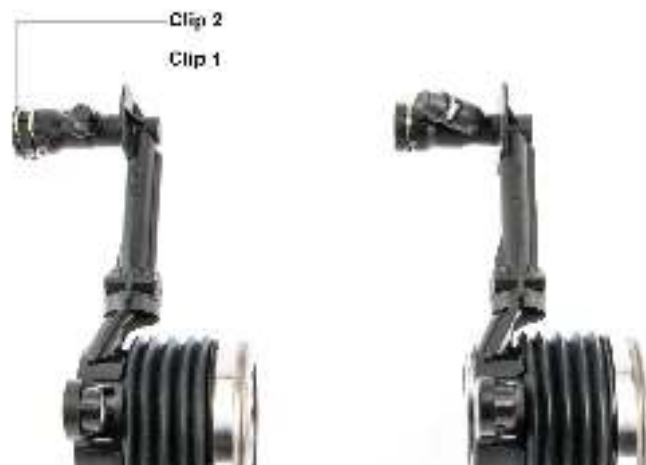
Photo 2: Previous design with one clip (right), new design with two clips (left)

The hydraulic connection of concentric slave cylinder 510 0097 10 has been modified. It now corresponds to the configuration used in current vehicle production. Unlike in the previous design (Photo 2, right), now two clips (Photo 2, left) are provided at the hydraulic connection point. Prior to installing the concentric slave cylinder, take note of the type of connector on the vehicle side, because a specific bleeding procedure must be followed depending on the design.

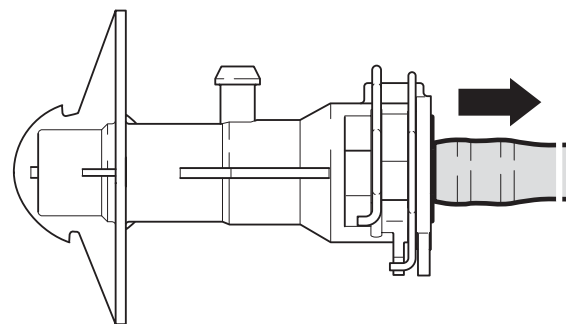
Photo 3: With the connector pulled out and the clips closed, the bleed hole is open

1. Open clip 2
2. Open clip 1
3. Pull the pipe out until it reaches the first stop
4. Close clip 1
5. Close clip 2
6. Pull the pipe out until it reaches the second stop (Photo 3)
7. Connect the bleeding device and switch it on
8. Remove air until liquid discharge is free of bubbles
9. Push the pipe in until it reaches the stop (Photo 4)
10. Switch off the bleeding device and remove it

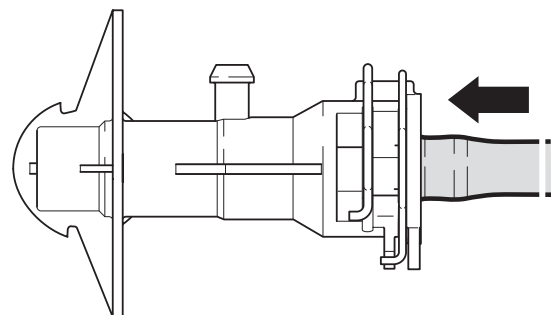
Photo 4: With the connector pushed in and the clips closed, the bleed hole is closed

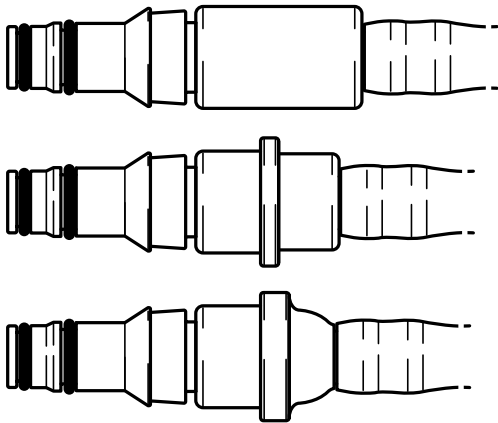
Photo 5: Vehicle-side connections with long flange

Bleeding procedure for vehicle-side connector with long flange (Photo 5):

1. Open clip 2
2. Open clip 1
3. Pull the pipe out until it reaches the stop (Photo 6)
4. Connect the bleeding device and switch it on
5. Remove air until liquid discharge is free of bubbles
6. Close clip 1
7. Close clip 2
8. Push the pipe on until it reaches the stop (Photo 7)
9. Switch off the bleeding device and remove it

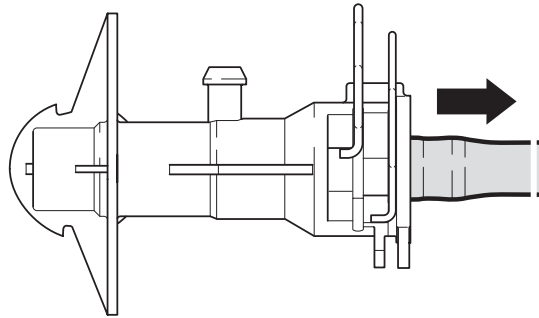
Photo 6: With the connector pulled out and the clips opened, the bleed hole is open

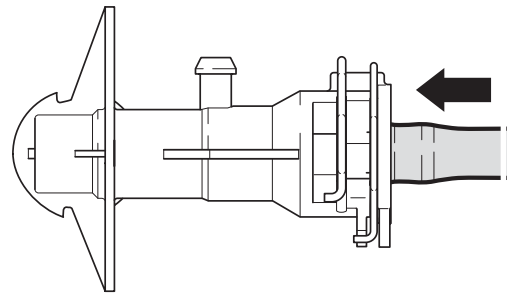
Photo 7: With the connector pushed in and the clips closed, the bleed hole is closed
