Service Info

Misalignment of diaphragm spring fingers

Manufacturers: PSA/Peugeot, Citroën

LuK RepSet: 623 3325 00
623 3325 09
623 3325 33
601 0021 00

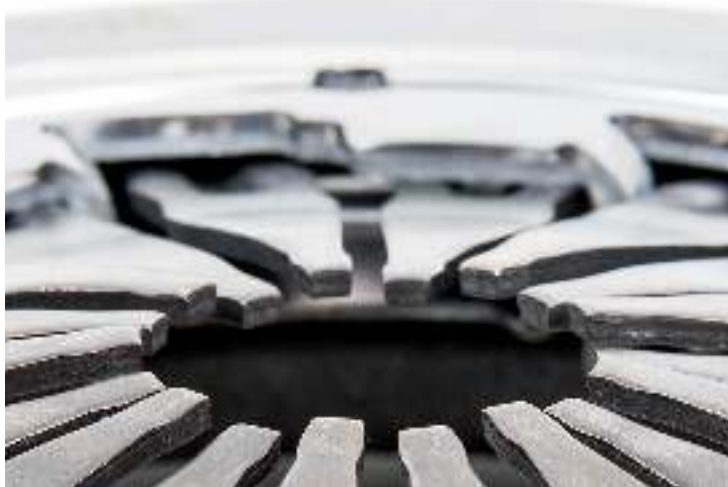
Fig. 1: Misalignment of diaphragm spring fingers on a dismantled clutch

The diaphragm spring fingers of the pressure plate in the LuK RepSet are misaligned in its uninstalled condition (Fig. 1). This design characteristic is safe and does not represent a component defect.

During the installation of the clutch, the diaphragm spring aligns itself to its working position. In so doing, the diaphragm spring fingers align themselves properly and provide the correct operation of the clutch.
