Wheel bearing kit including wheel bearing and axle nut

fits Audi A2, Seat Cordoba, Seat Ibiza IV, Škoda Fabia, VW Polo, VW Fox

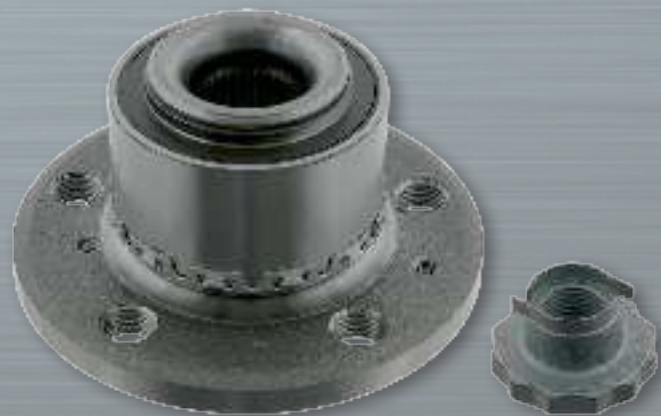
Water is getting into the wheel bearing due to a damaged sealing washer and rust is forming, see photos (1) and (2). The sealing washer (3) located between the CV joint and the wheel hub is made of plastic and is easily damaged during removal or due to external factors. When the sealing washer is damaged, it no longer makes proper contact. Water can get inside the wheel bearing more easily once the sealing washer is damaged or dirty. The consequences are premature failure of the bearing and a lot of noise.

Look out for damage to the sealing washer! As a general rule, SWAG recommends replacing the sealing washer when fitting a wheel bearing. Important: The sealing washer comes in two sizes (64 mm and 72 mm). Pay particular attention to the size (in inches) of the wheels!
