### Issue no. 04/2017: Leakage after fitting the oil filter insert OX 388D Eco in 1.6 and 2.0 TDI engines

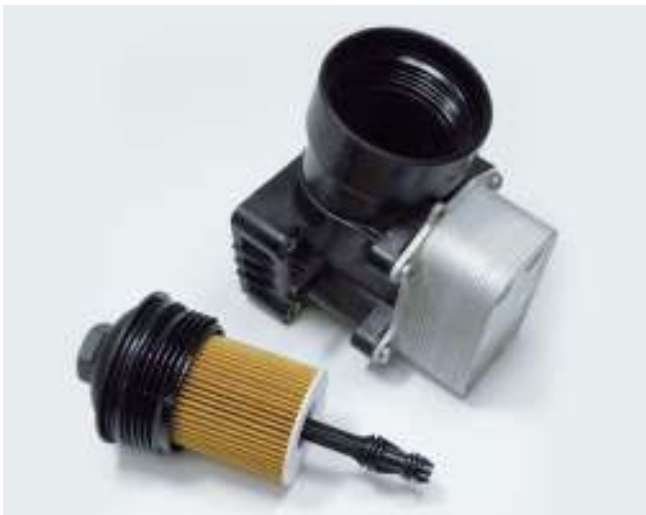
In diesel vehicles from the VW Group, the oil filter housing may leak in the engines indicated above following an oil change and the associated filter replacement. This can occur if excessive assembly torque is applied to the housing cover.

Figure 1: Oil filter module with oil filter insert OX 388D ECO

**Important!** When changing the filter, always use a torque spanner to ensure compliance with the manufacturer's specifications. To prevent damage, coat the new gaskets with clean engine oil before fitting.
