Technical Report #67

Failure reasons for oil seals

Due to the claims received by oil leakage of the oil seals, we want to report the common faults observed in their installation, as well as advice our customers tips in order to avoid the oil leakage.

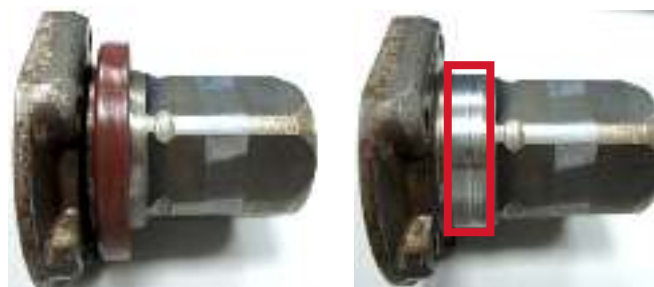
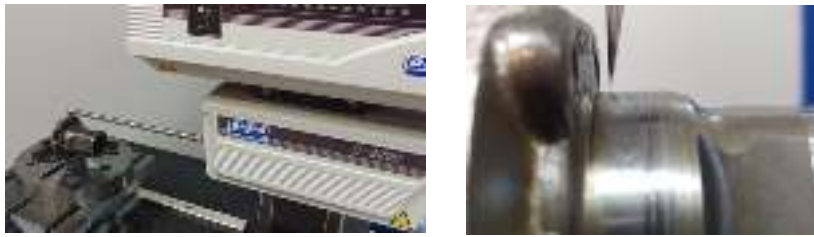
Profile of the contact surface between the seal and the shaft where it's observed wear generated by the sealing lip (mm)

The shaft must be checked to found imperfections that can affect the sealing lip. In some cases, the sealing lip can wear out the surface of the shaft, creating a groove which through of it can produce leakage.

If the shaft is worn in depth, or has been damaged during the disassembly process of the old seal, it will be necessary to repair or replace the shaft, to ensure that the contact surface is in perfect condition.

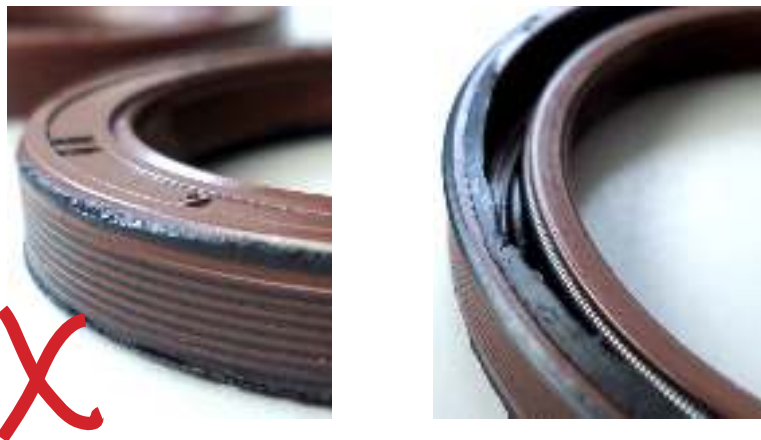
Sealant remains in the external diameter of the seal

No sealants or oil must be applied to the external diameter of the seal or in the housing. The contact of these places should be dry and tight so it can seal properly. This seal could reach the sealing lip canceling the operation of the oil seal.

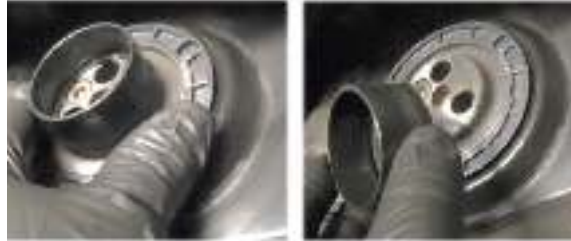
It is very important to assemble them without lubricating the internal sealing lip, using the applicator that comes with the seal to mount it on the shaft without damaging the lip.

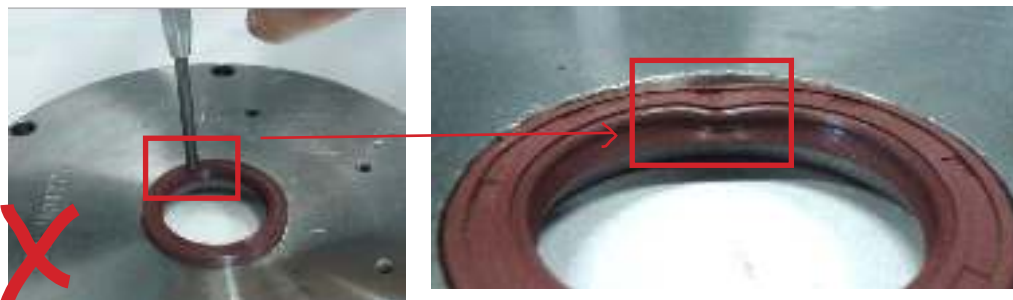
It is totally forbidden to directly strike with the hammer the seal or to use of any punch element to insert it into its housing, as this could cause deformations in the metal core, resulting leakage of oil.

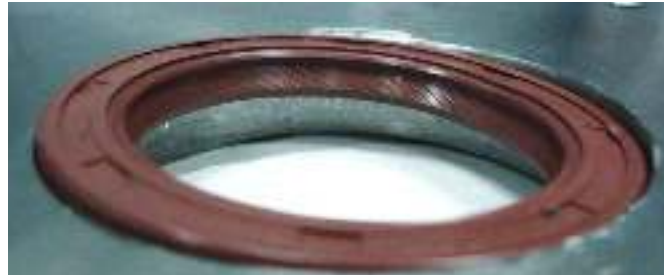
In the following picture, we can see how the seal cannot be perpendicular to the shaft due to the deformation produced in the metal core.

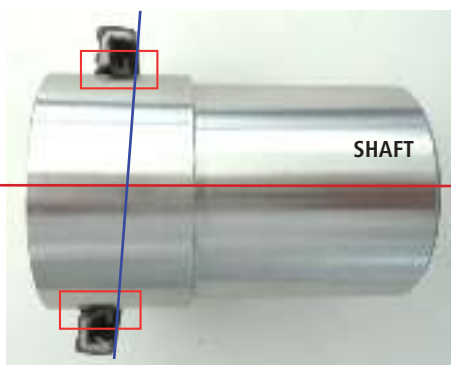
Seal perpendicular to the axis

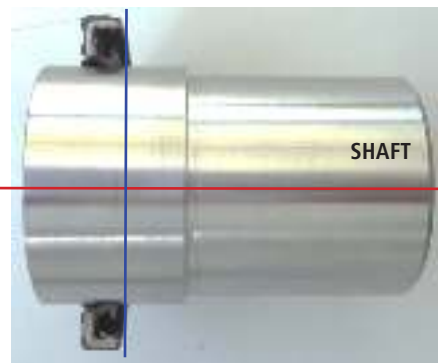
Seal not perpendicular to the axis

The following pictures we can see the indicated mounting defect:

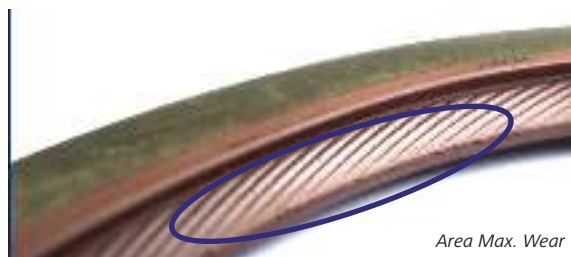
Area Max. Wear

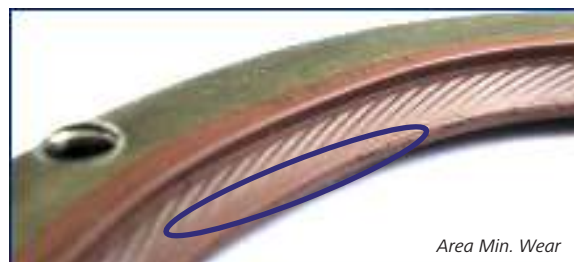
Area Min. Wear

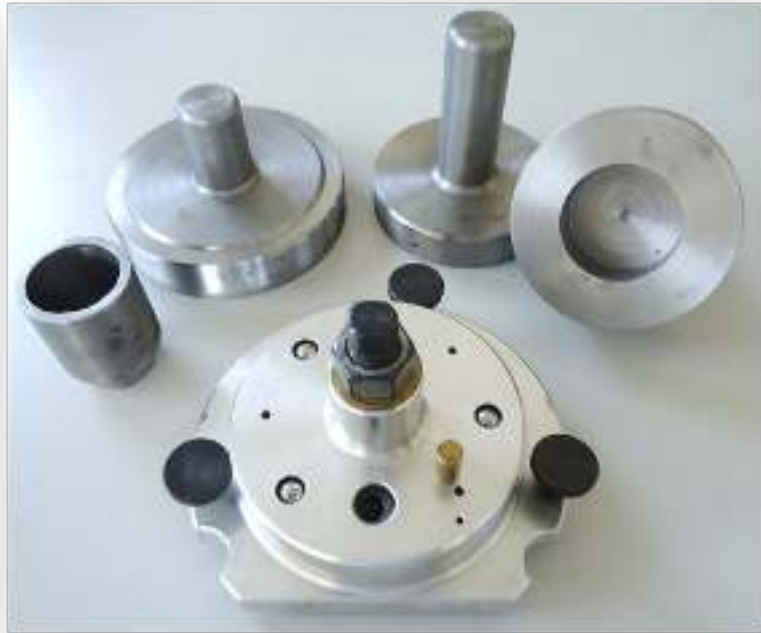
Examples of installing tools

The assembling it must be done by an adequate tool that allows the oil seal to be inserted into its housing at the same time throughout its diameter, in this way, we can ensure that the oil seal is perfectly perpendicular to the axis where it is mounted, making sure that the internal lip acts in the same way on the entire surface of contact with the shaft.
