Water pumps

Typical damage patterns and their causes

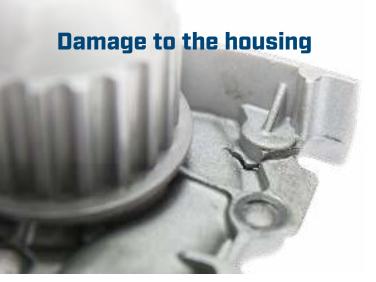
The problem:

Incorrect alignment when installing the water pump and over-tightend screws lead to strain which can cause fissures in the housing. These structural damages lead to leaks and eventually failure.

Possible effects:

- water pump leakage
- · engine damage

MEYLE's advice:

To ensure strain-free installation clean the seal face thoroughly, hand tighten the screws. Follow the installation procedures recommended by the vehicle manufacturer and apply the specified torques. Only use the respective fastening bolts for water pump assembly and tighten them to the torque specified by the manufacturer.

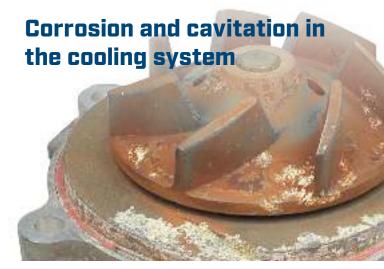
The problem:

Insufficient and/or incorrect coolant additives cause corrosion, scaling and cavitation in the cooling system with negative effects on the water pump components and risk of mechanical seal contamination as well as early wear of the slide rings.

Possible effects:

- leakage
- · cavitation damage
- · damage to other cooling system components
- · early slide ring wear

MEYLE's advice:

Check the coolant condition on a regular basis and observe the replacement intervals specified by the vehicle manufacturer at all times.

Note: Never blend different types of coolant.

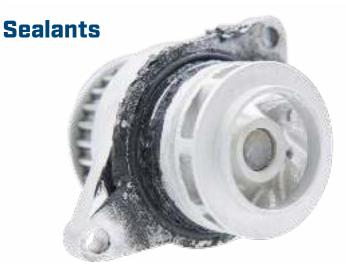
The problem:

Cooling system contaminated owing to incorrect use of silicon sealant.

Possible effects:

- · mechanical seal damage
- · clogging of the coolant system

MEYLE's advice:

Only use the sealant provided with the MEYLE product or recommended by the vehicle manufacturer.
Use silicon sealant sparingly and protect the cooling system from sealant ingress.
