Issue no. 03/2018: Damaged oil filter paper

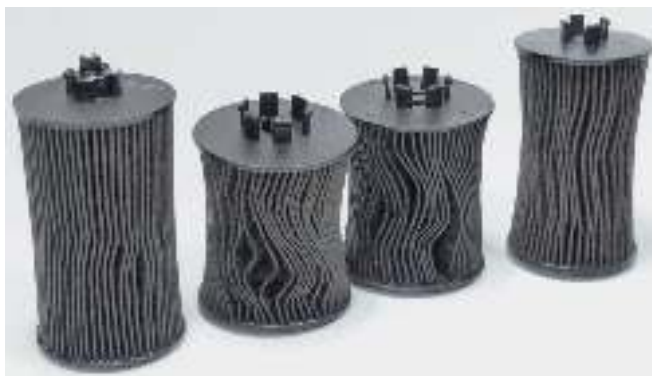
- The first and most common reason is noncompliance with proper maintenance and replacement intervals. The oil filter is worked too hard, reaches its maximum absorption limit, and collapses.
- The second possibility is continued operation at high engine temperatures. This makes the filter paper age faster and the impregnation layer become brittle. The result: the cellulose fibers break down, the paper tears, and the filter disintegrates.

Figure 1: Collapsed oil filter inserts

IMPORTANT: Besides complying with the manufacturer's specifications, oil and filter changes should always be adapted to suit the individual driving profile! The use of high-quality engine oil can also reduce the load on the oil filter significantly.

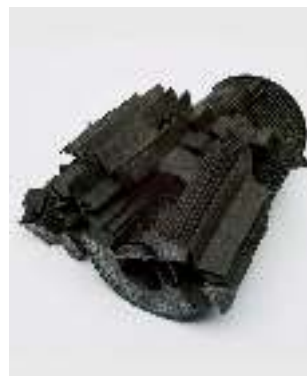
Figure 2: Disintegrated oil filter insert

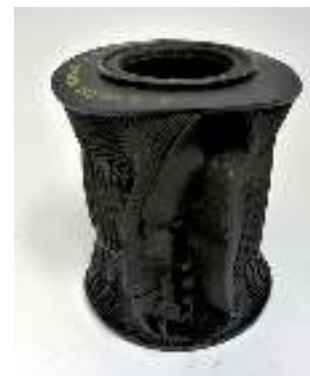
Figure 3: Oil filter insert deformed/torn as a result of overheating
